**IMPROVEMENT WORKS FOR VENTILATION AND ACCESS TO VOIDS  
ON BLOCKS 1 ON JARDÍN 3, 1 ON JARDÍN 5, 7 ON JARDÍN 7, 11 ON  
JARDÍN 13, AND 10 ON LA ISLA, ON CONDADO DE ALHAMA  
PROPERTY COMPLEX, ALHAMA DE MURCIA, MURCIA.  
PROJECT MANAGER'S REPORT**

**BUILDER: ALCOMVI 10 S.L.**

**DEVELOPER: CONDADO DE ALHAMA PROPERTY  
COMPLEX**

**DATE: 3RD MARCH 2019**

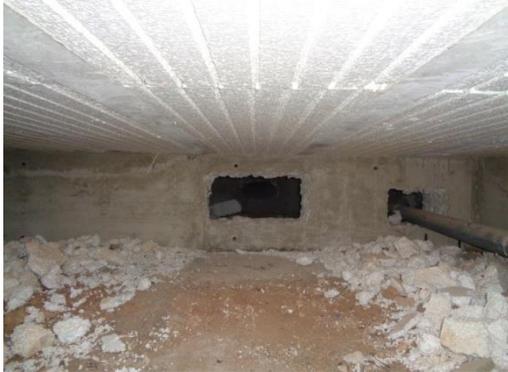
LA ISLA BLOCK 10

As has already been indicated in detail in the report corresponding to this block, the space is divided longitudinally and transversely, and in this case, action was taken in one of the block modules.

General view of interior.

6 ventilations have been carried out on the facade of the main street, and two indirect exterior ventilations on the wall.

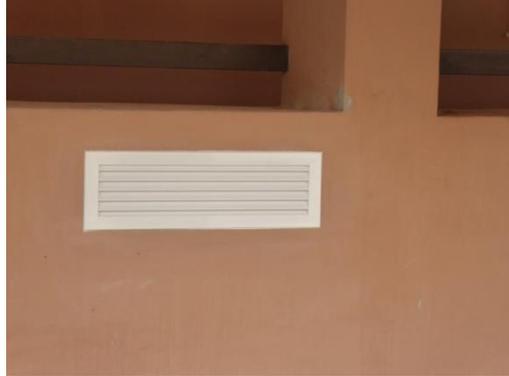
General view of ventilation on rear facade.

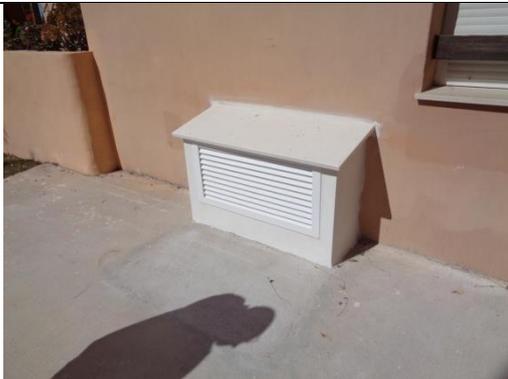
View of wall ventilation.

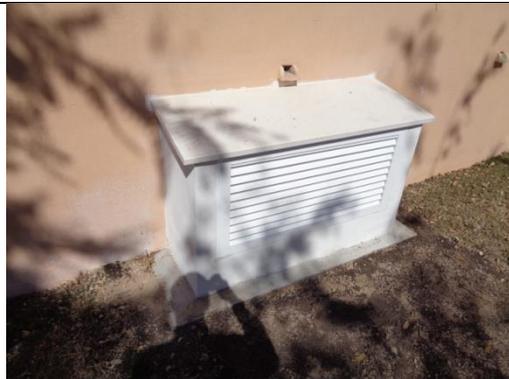
View of wall ventilation.

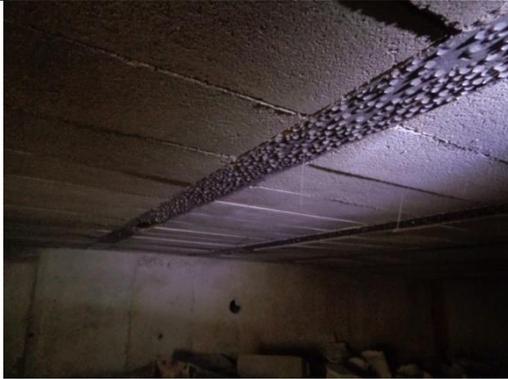
JARDINES 3 BLOQUE 1

The interior space of the void is divided by concrete walls, both longitudinally and transversely, and it is estimated that 47 interior passageways would need to be made in order to obtain effective ventilation.

General view of interior.

It was agreed to make the required interior perforations in the future, together with further perforations in the concrete walls, so that a more competitive price may be obtained.

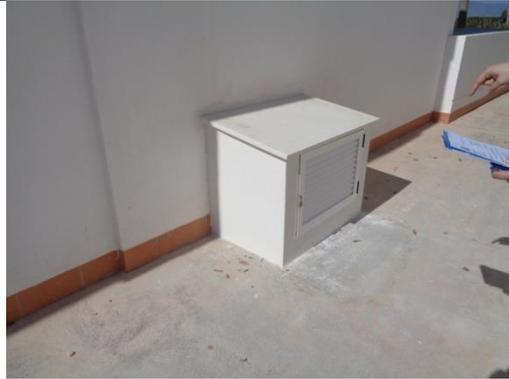
One ventilation with indirect access has been carried out, and given the large amount of interior perforations that would need to be made on the concrete walls in order to obtain effective ventilation, no further work has been carried out.

General view of ventilation and indirect exterior access.

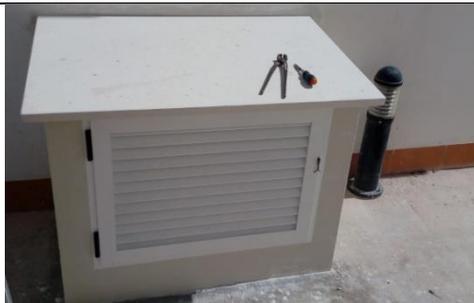
JARDÍN 3 BLOCK 2

The interior space of the void is divided by concrete walls, both longitudinally and transversely. Interior passageways would need to be made in order to obtain effective ventilation.

One ventilation with indirect access has been carried out, and given the large amount of interior perforations that would need to be made on the concrete walls in order to obtain effective ventilation, no further work has been carried out.

View of ventilation with access carried out.

It was agreed to make the required interior perforations in the future, together with further perforations in the concrete walls, so that a more competitive price may be obtained.

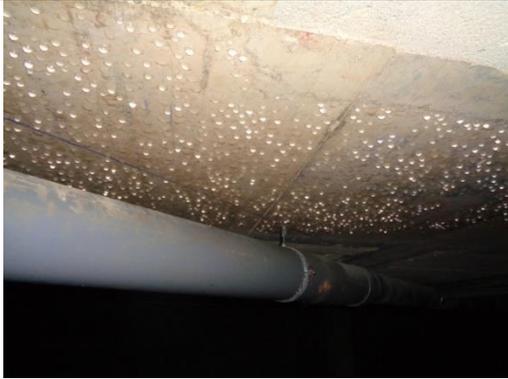
JARDÍN 5 BLOCK 1

The interior space is totally open, with no internal divisions, and the height of the space is 1.50m, which is reduced at one end.

View of interior prior to intervention.

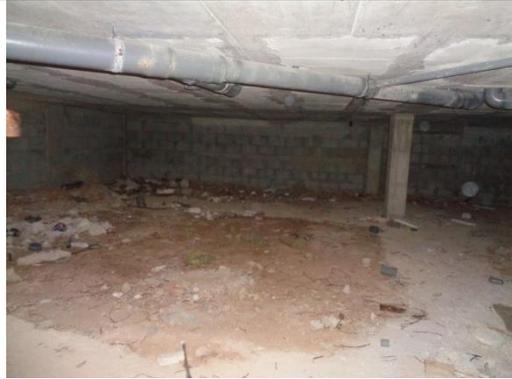
In the case of Jardín 5, the reduction in relative damp is considerably lower, possibly because in this void, the height of one of the ends is considerably reduced, hindering ventilation.

General view of interior after ventilation.

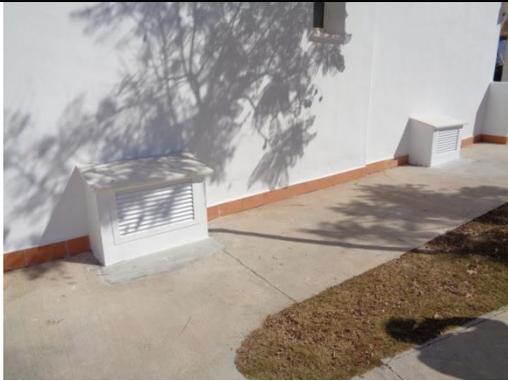
View of wall ventilation.

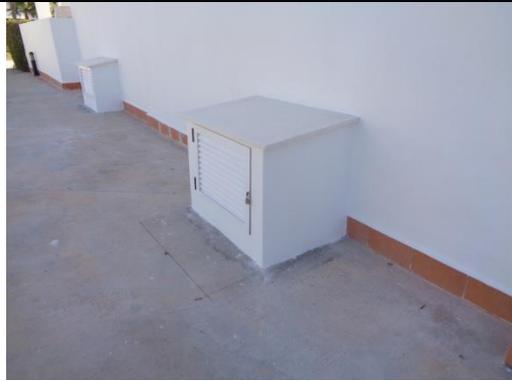
General view of ventilation and access.

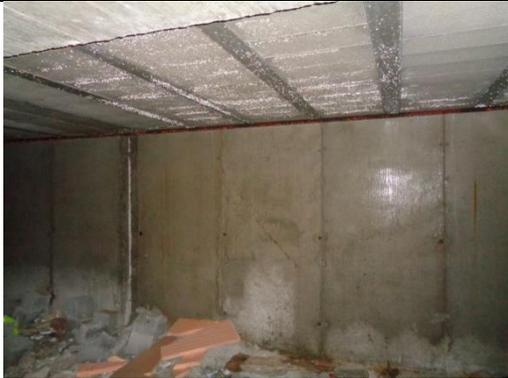
JARDÍN 7 BLOCK 7

The interior space is totally open, with no internal divisions, with a height close to 1.90m. It already had two direct ventilations with access, one on each wall.

View of interior prior to intervention.

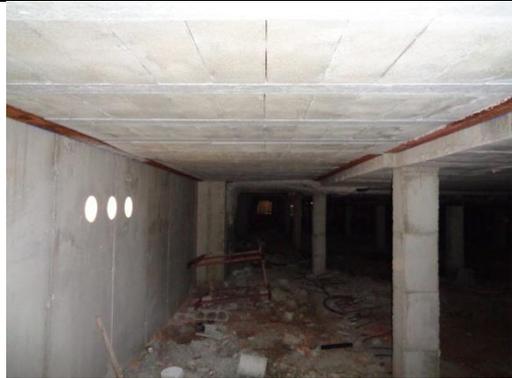
We should also highlight that at the time of the second visit, once all the ventilations had been carried out, it was noted that on block 7 of Jardín 7, there was a small loss in sanitation, which will need to be repaired if this has not already been done.

General view of interior after ventilation.

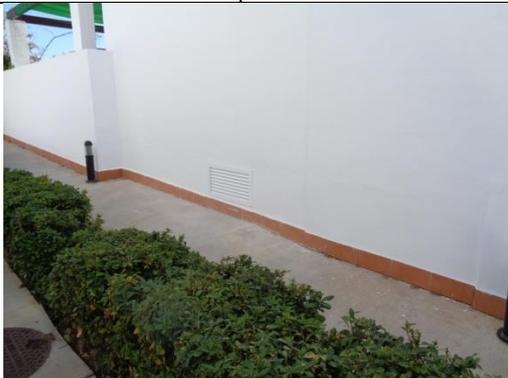
View of wall ventilation.

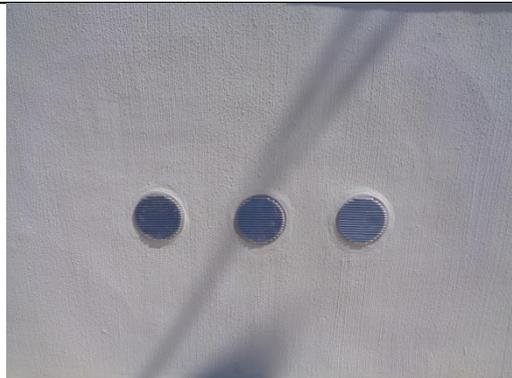
On the wall giving out onto the street (rear facade), 4 direct exterior ventilations have been carried out on the concrete wall with three perforations, each one 200 in diameter.

Ventilation on rear facade.

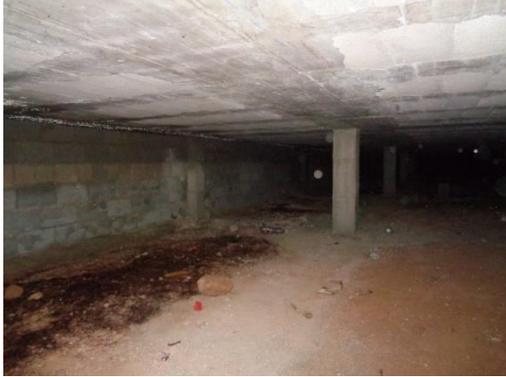
JARDÍN 13 BLOCK 11

The interior space is not divided, and it has an approximate height of 1.50m. It has an existing access at the base of a manhole cover.

View of interior prior to intervention.

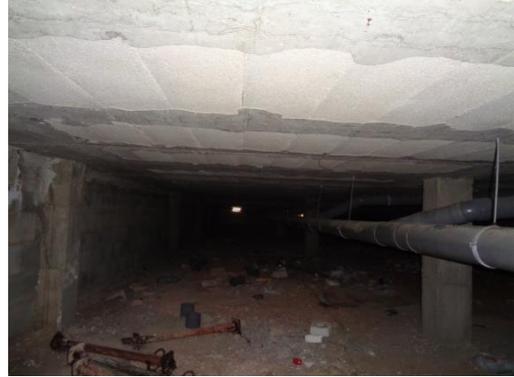
General view of interior after ventilation.

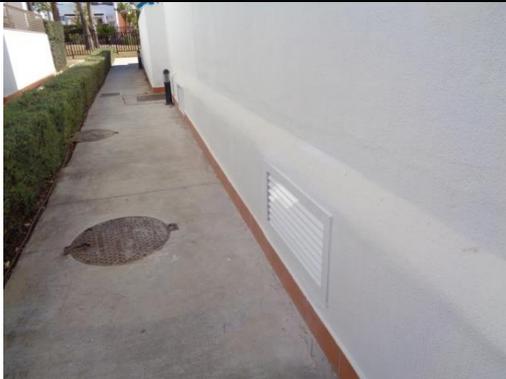
View of wall ventilation.

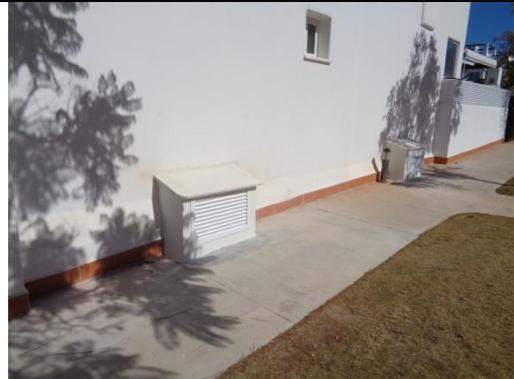
General view of ventilation and access.

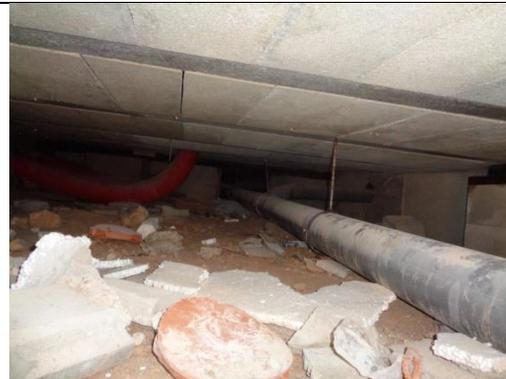
NARANJOS 5 BLOCK WITH PROPERTY 381

The space is divided longitudinally, and is of reduced height, between 40 and 50cm.

View of interior prior to intervention.

It would be advisable to carry out more ventilations and accesses, until there are at least two on each wall, and if possible, ventilations of small dimensions on main and rear facades.

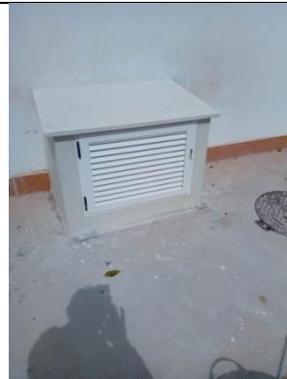
General view of interior after ventilation.

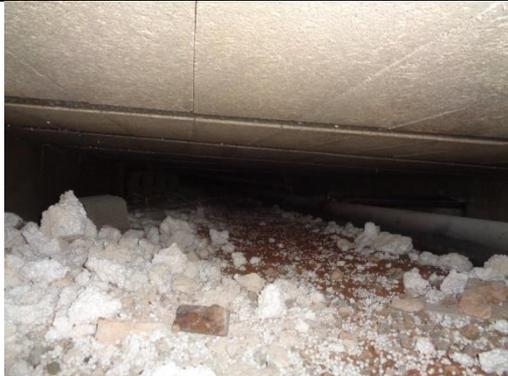
NARANJOS 8 BLOCK WITH PROPERTY 697

In this case, it can be indicated that considerable damp was observed on the inner face of the void, which may not be caused by condensation. It would be necessary to inspect the corresponding property or observe the development of the damp described.

As previously stated, on the block on Naranjos 8 with property 697, there is considerable damp, the origin of which will need to be verified, as it may not be due to condensation.

View of interior prior to intervention.

Similarly, it would be recommended to carry out more ventilations and accesses, the same as indicated in the previous case.

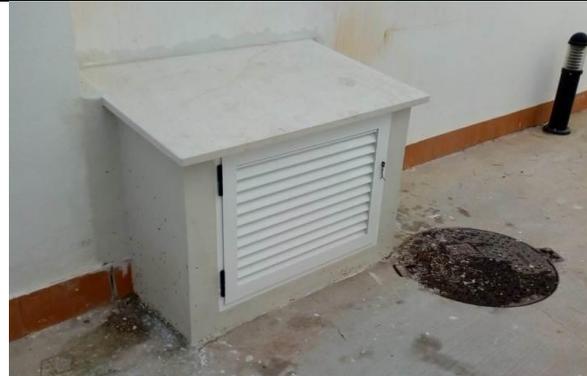
General view of interior after ventilation.
