**REPORT ON THE STATE OF GARDENING
IN VILLA JANA
CONDADO DE ALHAMA GOLF RESORT**

8th - June - 2022

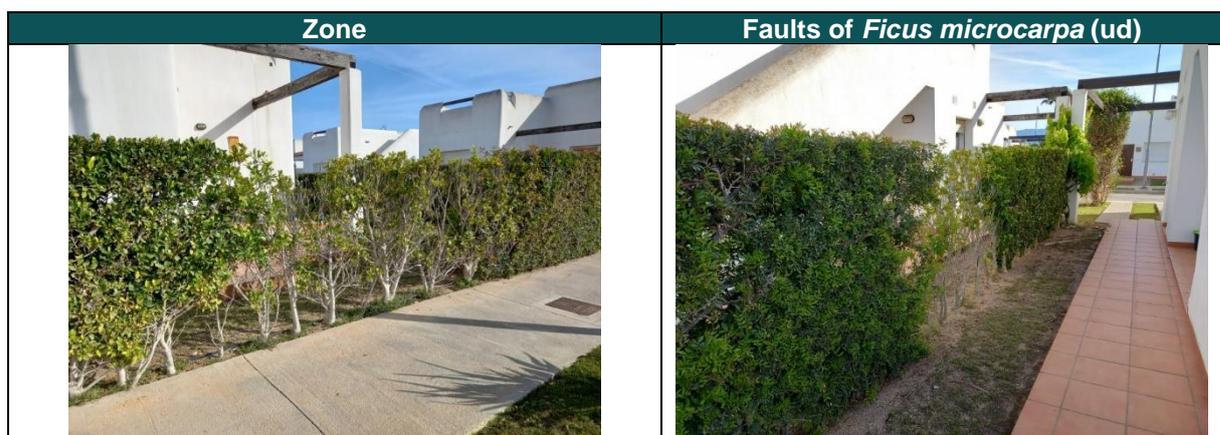
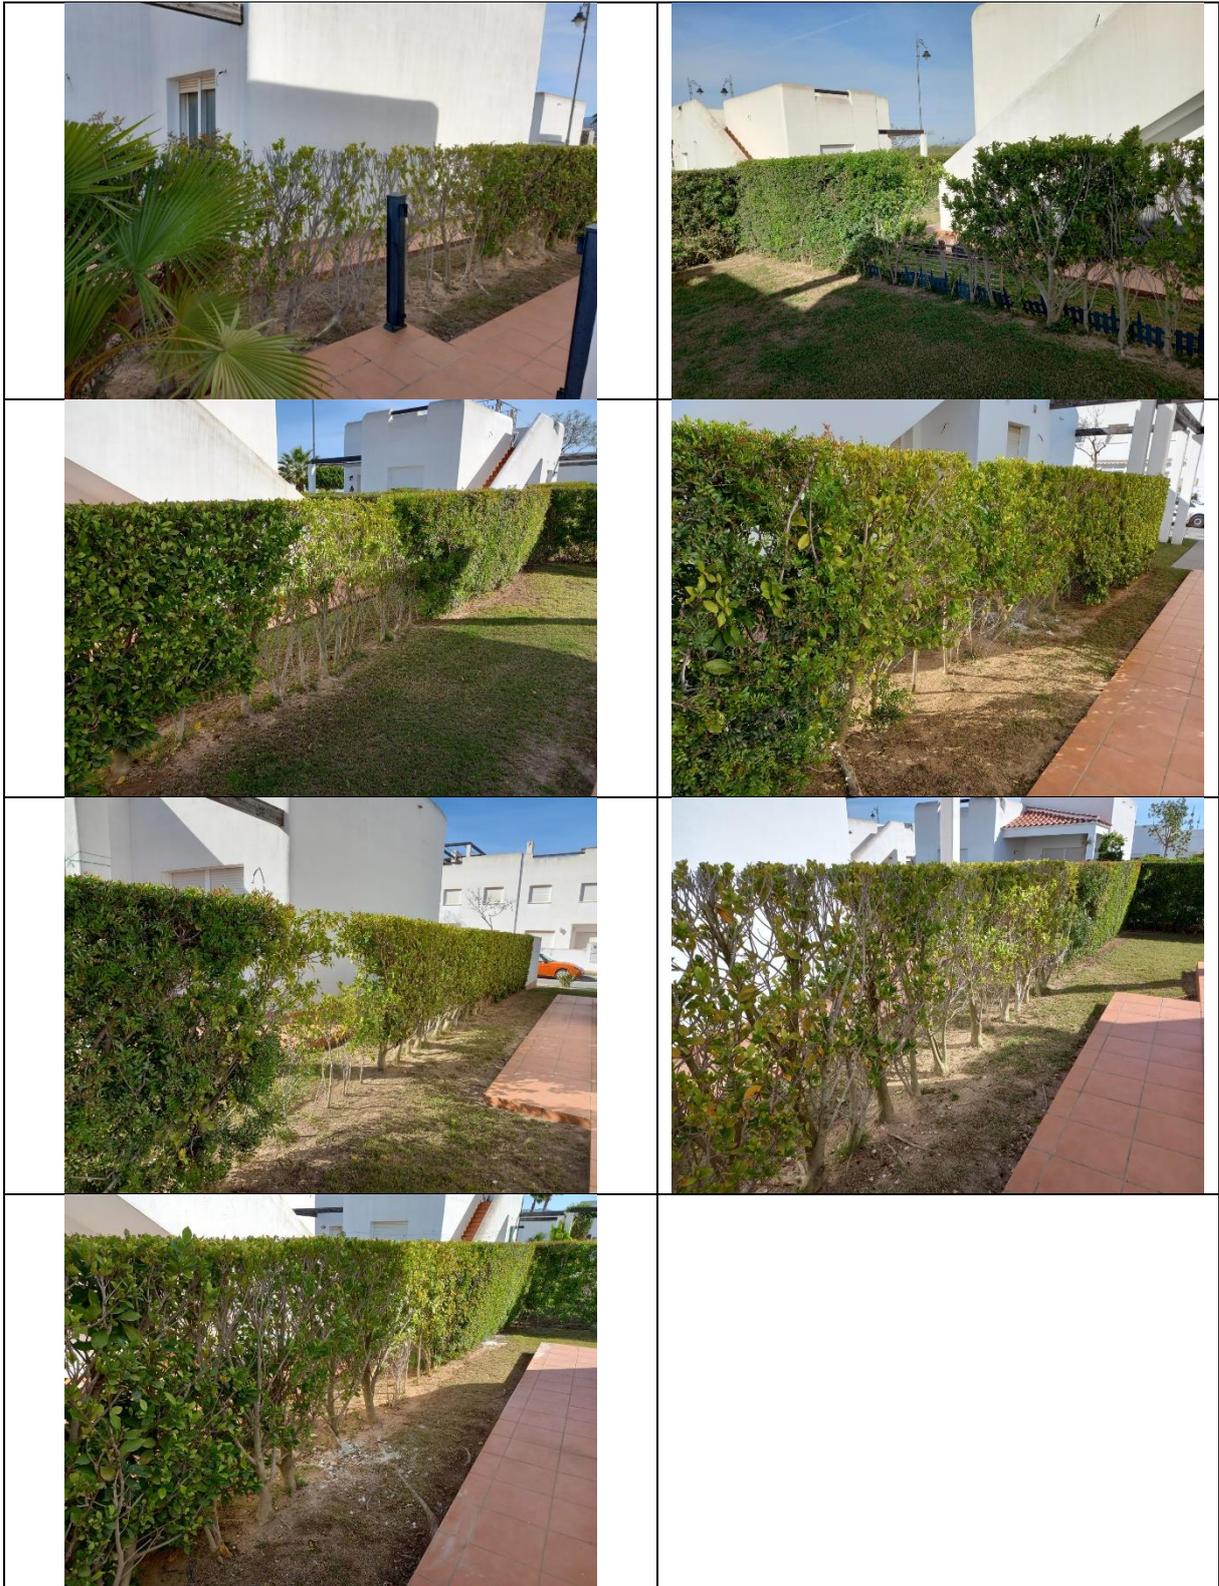
On the other hand, several areas have been identified where the *Ficus microcarpa* hedge is in an advanced state of senescence. For this reason, the following section gives a brief overview of the number of affected units in each of the houses.

The following table shows the number of *Ficus microcarpa* hedgerows in each of the affected villages.

Zone	Faults <i>Ficus microcarpa</i> (ud)
Villa Jana 1-3	12
Villa Jana 17-10	18
Villa Jana 19-21	12
Villa Jana 21-23	18
Villa Jana 23-25	18
Villa Jana 26	15
Villa Jana 22-20	12
Villa Jana 20-18	18
Villa Jana 4-2	12
Total	135

- With regard to the Ficus microcarpa hedge, up to 135 decrepit units can be found, but their elimination cannot be localised as their roots are very developed and intertwined with each other.
- As a solution to this problem, it is proposed to replace the entire line of Ficus microcarpa hedges with a new Pistacia lentiscus variety and natural grass.

This proposal consists of the complete removal of the current Ficus microcarpa hedge that divides the villas, as well as the removal of the roots. In addition, the decrepit grass surface will be removed as a result of the pressure of the hedge's roots.

Replacement of the Ficus hedge with another variety of mastic tree and replacement of the grass surface with a new batch of natural grass of the Bermuda variety (*Cynodon dactylon*).

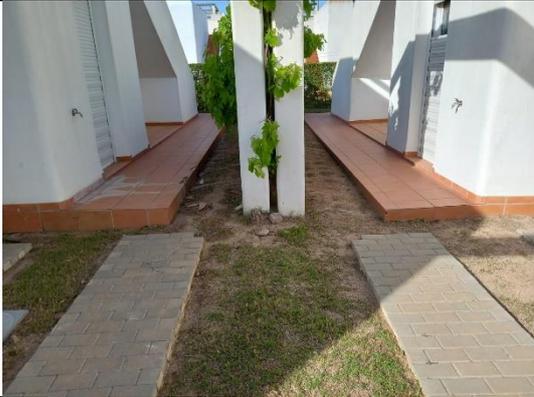
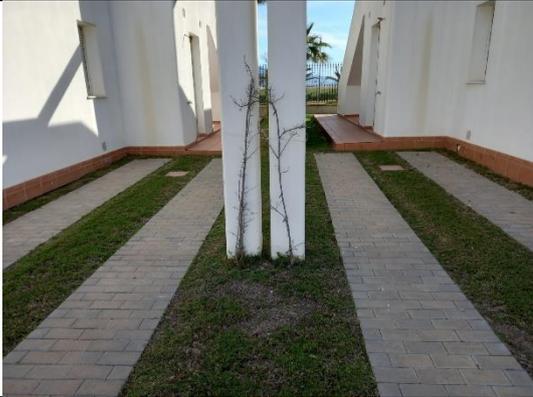
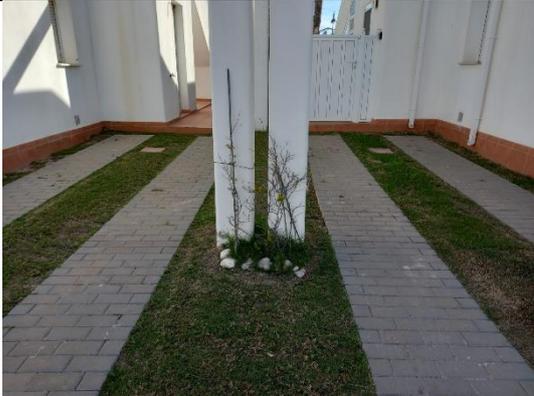
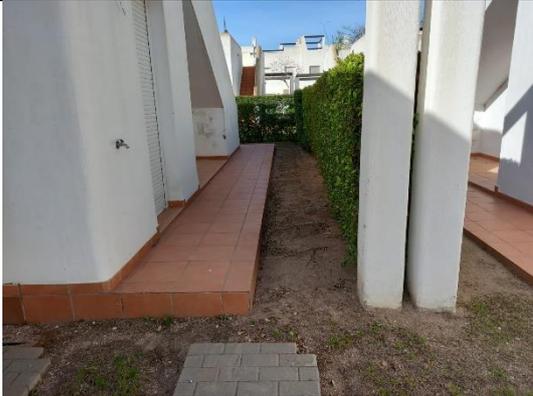
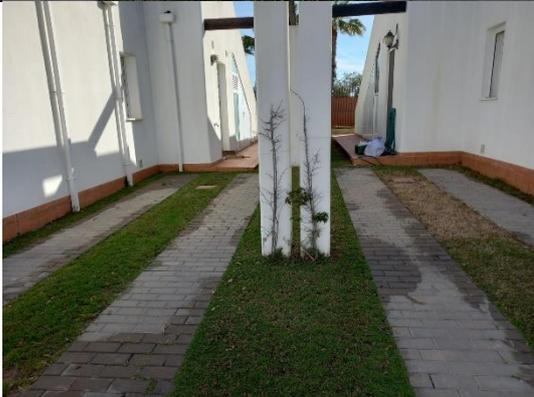
Zone	Faults of <i>Bougainvillea</i> (ud)

The following table gives a count of the number of *Bougainvillea* spp. bushes in each of the affected villages.

Zone	Faults de <i>Bougainvillea</i> (ud)
Villa Jana 23-21	2
Villa Jana 19-17	2
Villa Jana 14-12	2
Villa Jana 15-13	2
Villa Jana 11-9	2
Total	10

- At present, Bougainvillea spp. shrubs are not developed for different reasons, one of them being the high compaction of the soil on which the garden sits, which greatly conditions the development of plants that do not yet have a developed root system.
- Therefore, as a solution to this problem, STV Gestión proposes the replacement of the current Bougainvillea spp. units with larger ones that have a developed root system that allows them to adapt to the soil in the best possible conditions.

This proposal aims to act on the number of dwellings with small Bougainvillea specimens. In those columns(5) where 2 Bougainvillea spp. can be found, a pyramidal Bougainvillea glabra specimen of about 3 m in height will be supplied, i.e. a total of 5 new Bougainvilleas.
